# Application News

## No. A509

## Analysis of Tapwater Contaminants by FTIR and EDX Spectroscopy

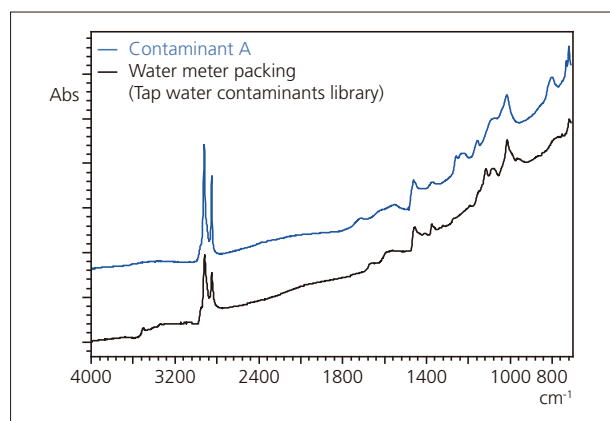
Fig. 2 ATR Spectra of Contaminant A and Spectra Search Result

The contaminant was collected and examined by single-reflection attenuated total reflection (ATR) measurement. The ATR spectrum we obtained and spectra search results are shown in Fig. 2. The ATR spectra matches an entry in the tap water contaminant library, based on which the contaminant is inferred to be an ethylene propylene diene rubber (EPDM) with additives that include talc and kaolin.

#### Library Information for Water Meter Packing

Materials: Ethylene propylene diene rubber (EPDM), magnesium silicate (TALC), aluminum silicate (KAOLIN).  
Major elements: Si, Mg Color: Black Shape: Rubber/fragment  
Hardness: Soft Metallic luster: No Technique: ATR (Ge)

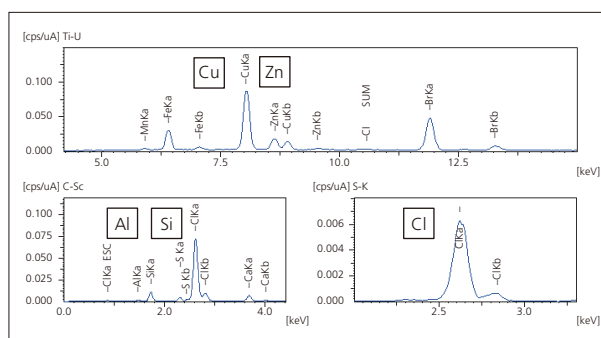
Fig. 3 Qualitative and Quantitative Results for Contaminant A Obtained by EDX Analysis

Results of qualitative and quantitative analysis of  $^{60}\text{Co}$ - $^{92}\text{U}$  are shown in Fig. 3. Based on the results of FTIR analysis, EPDM ( $\text{C}_5\text{H}_8$ ) was used as the balance<sup>1)</sup>. Si and Al come from talc and kaolin, which corroborates the data obtained by FTIR analysis. Cl is present in chlorine used in tap water, and metallic elements such as Cu and Zn are presumed to come from elution and deposition of water supply parts.

Constituent	Cl	Si	Al	Ca	S	Cu
Quantitative value (%)	1.48	0.57	0.19	0.10	0.070	0.021

Constituent	Fe	Br	Zn	Mn	C <sub>5</sub> H <sub>10</sub>
Quantitative value (%)	0.013	0.007	0.003	0.001	97.6

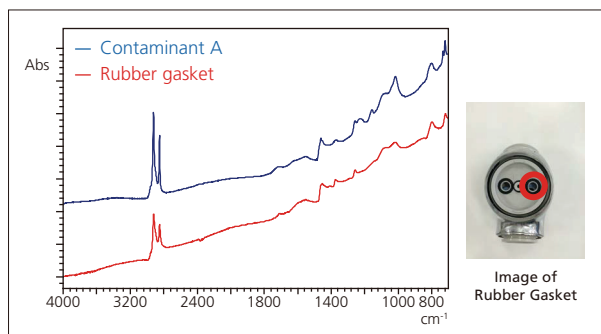
Fig. 4 ATR Spectra of Contaminant A and Rubber Gasket

The shower head was disassembled further and the filter and other parts analyzed by FTIR spectroscopy. The spectra obtained for Contaminant A showed similarities to the spectra obtained from a rubber gasket. The ATR spectra obtained are shown in Fig. 4. Contaminant A was identified as a fragment of this rubber gasket that had attached itself to the inside of the shower head.

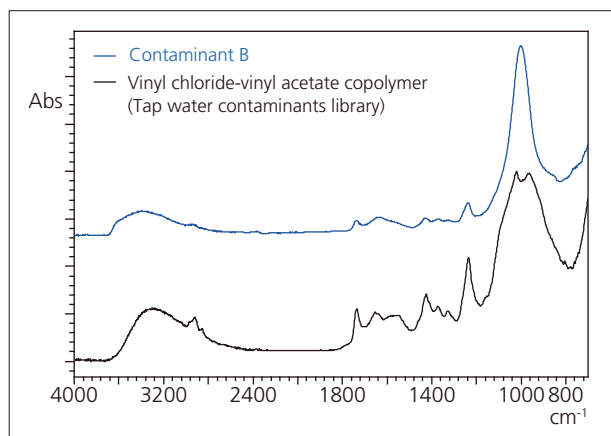
Fig. 6 ATR Spectra of Contaminant B and Spectra Search Result

The contaminant was collected and examined by single-reflection attenuated total reflection (ATR) measurement. The ATR spectrum we obtained and spectra search results are shown in Fig. 6. The ATR spectrum matched the tap water contaminants library data entry, and based on this was presumed to be a vinyl chloride-vinyl acetate copolymer.

Library Information for Vinyl Chloride-Vinyl Acetate Copolymer

Materials: Vinyl chloride-vinyl acetate copolymer  
Major elements: Cl, Fe Color: Brown Shape: Splinter  
Hardness: Soft Metallic luster: No Technique: ATR (Ge)

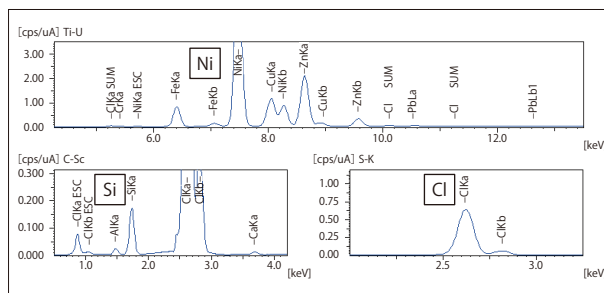
Fig. 7 Qualitative and Quantitative Results for Contaminant B Obtained by EDX Analysis

Results of qualitative and quantitative analysis of  $^{63}\text{C}$ - $^{92}\text{U}$  are shown in Fig. 7. Based on the results of FTIR analysis, vinyl acetate ( $\text{C}_4\text{H}_6\text{O}_2$ ) was chosen as the balance, the Cl detected was considered to be from vinyl chloride ( $\text{C}_2\text{H}_3\text{Cl}$ ), and other elements were quantified as metals. Ni was presumed to come from elution and deposition of metal plating inside the tap water outlet over a long period of time, while other elements came from supply piping and other components or from water scale.

Constituent	$\text{C}_2\text{H}_3\text{Cl}$	Si	Ni	Al	Zn	Fe
Quantitative value (%)	56.4	1.63	1.22	0.43	0.34	0.23

Constituent	Cu	Ca	Cr	Pb	$\text{C}_4\text{H}_6\text{O}_2$
Quantitative value (%)	0.20	0.13	0.010	0.006	39.4

Water supply pipes are made from vinyl chloride, while vinyl chloride-vinyl acetate copolymers are commonly used as seal materials at connection points. Contaminant B is presumed to be a piece of this seal material that has flaked off into the water due to degradation occurring over time. No parts around the tap water outlet were found that matched the constituents of Contaminant B.
