High-Speed Video Camera

Observing the Fracture of Unidirectional CFRP in Static Tensile Testing

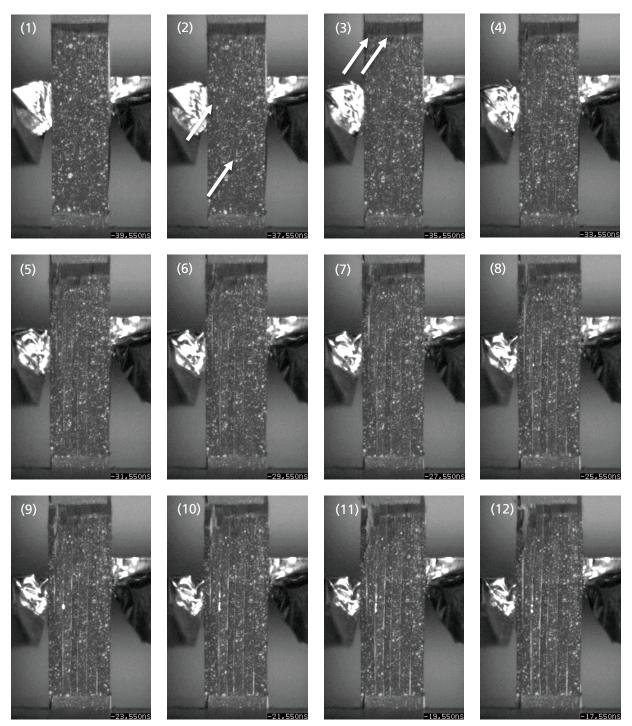
Fig. 4 Captured Images (Interval between captured images is 2 µs.)

The failure of unidirectional CFRP is shown in Fig. 4. Longitudinal cracks can be seen on the left side of the specimen in image (2) of Fig. 4. In image (3), these cracks have propagated as far as the upper tab. Longitudinal cracks can also be seen on the right side of the sample in image (3). Image (6) is a later view of the sample as it is breaking apart. Using the HPV-X2 allows for the observation of CFRP failure during static tensile tests, which is useful for future CFRP development.
